DRYWALL CONTRACTORS ASSOCIATION OF NEVADA

Crack Repair System – Use the Right Stuff!

Published October 2021

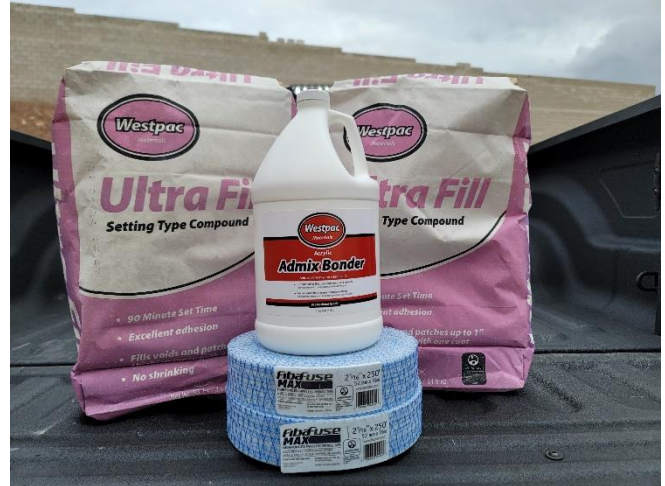
FibaFuse Max Tape: This is a high strength fiberglass mat with mesh weave over the top. This product absorbs compound well and had great crack resistance in the lab and field.

Westpac Acrylic Ad Mix: This is an acrylic bond mix that improves the strength and flexibility of joint treatment products. It should be used in place of water to mix Westpac Ultrafill.

Westpac Ultrafill: This a hot mud product that is interlaced with fiberglass. It is very strong and dries extremely hard. This product should be used to embed and wipe down the FibaFuse Max Tape in the repair area.

Regular joint treatment products can be used to finish over the top of this system.
