# DRYWALL CONTRACTORS ASSOCIATION OF NEVADA

## Pin Holing in Wall Texture

October 18, 2018

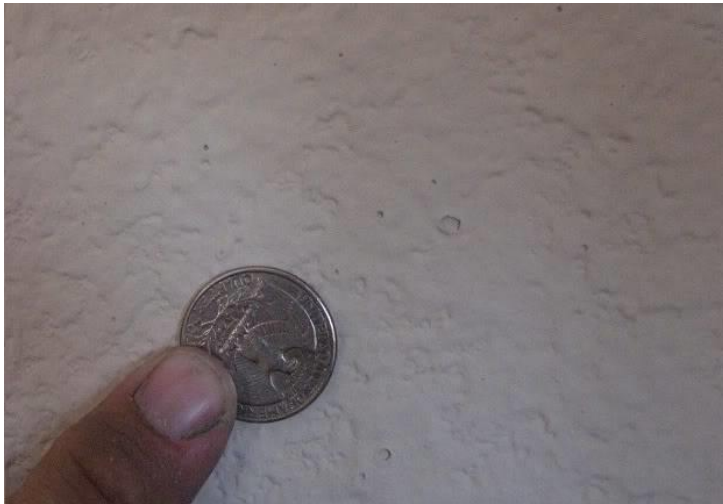
The appearance of some small Pin Holes in the surface of the wall texture is a normal occurrence and is common in the industry. Pin Holes are more prevalent in machine applied texture and heavier texture patterns such as knockdown.

This picture illustrates what Pin Holes look like in a finished wall. Note the small and irregular holes next to the quarter.

Pin Holes are the result of air and moisture escaping out of the wall texture as the products dry on the wall. Upon close examination, some Pin Holes can be seen in nearly every home that has textured walls.

The industry standard for evaluating drywall finish is to stand 5' away from the surface at a perpendicular view angle with normal lighting conditions (See Gypsum Association *Recommended Levels of Finish for Gypsum Board* GA-214-2015, at page 4, Inspection Criteria). Pin Holes should not be visible from this distance.
